# Debris/Ice/TPS Assessment And Photographic Analysis For Shuttle Mission STS-38

Gregory N. Katnik  
NASA/Kennedy Space Center

February 1991

November 15, 1990

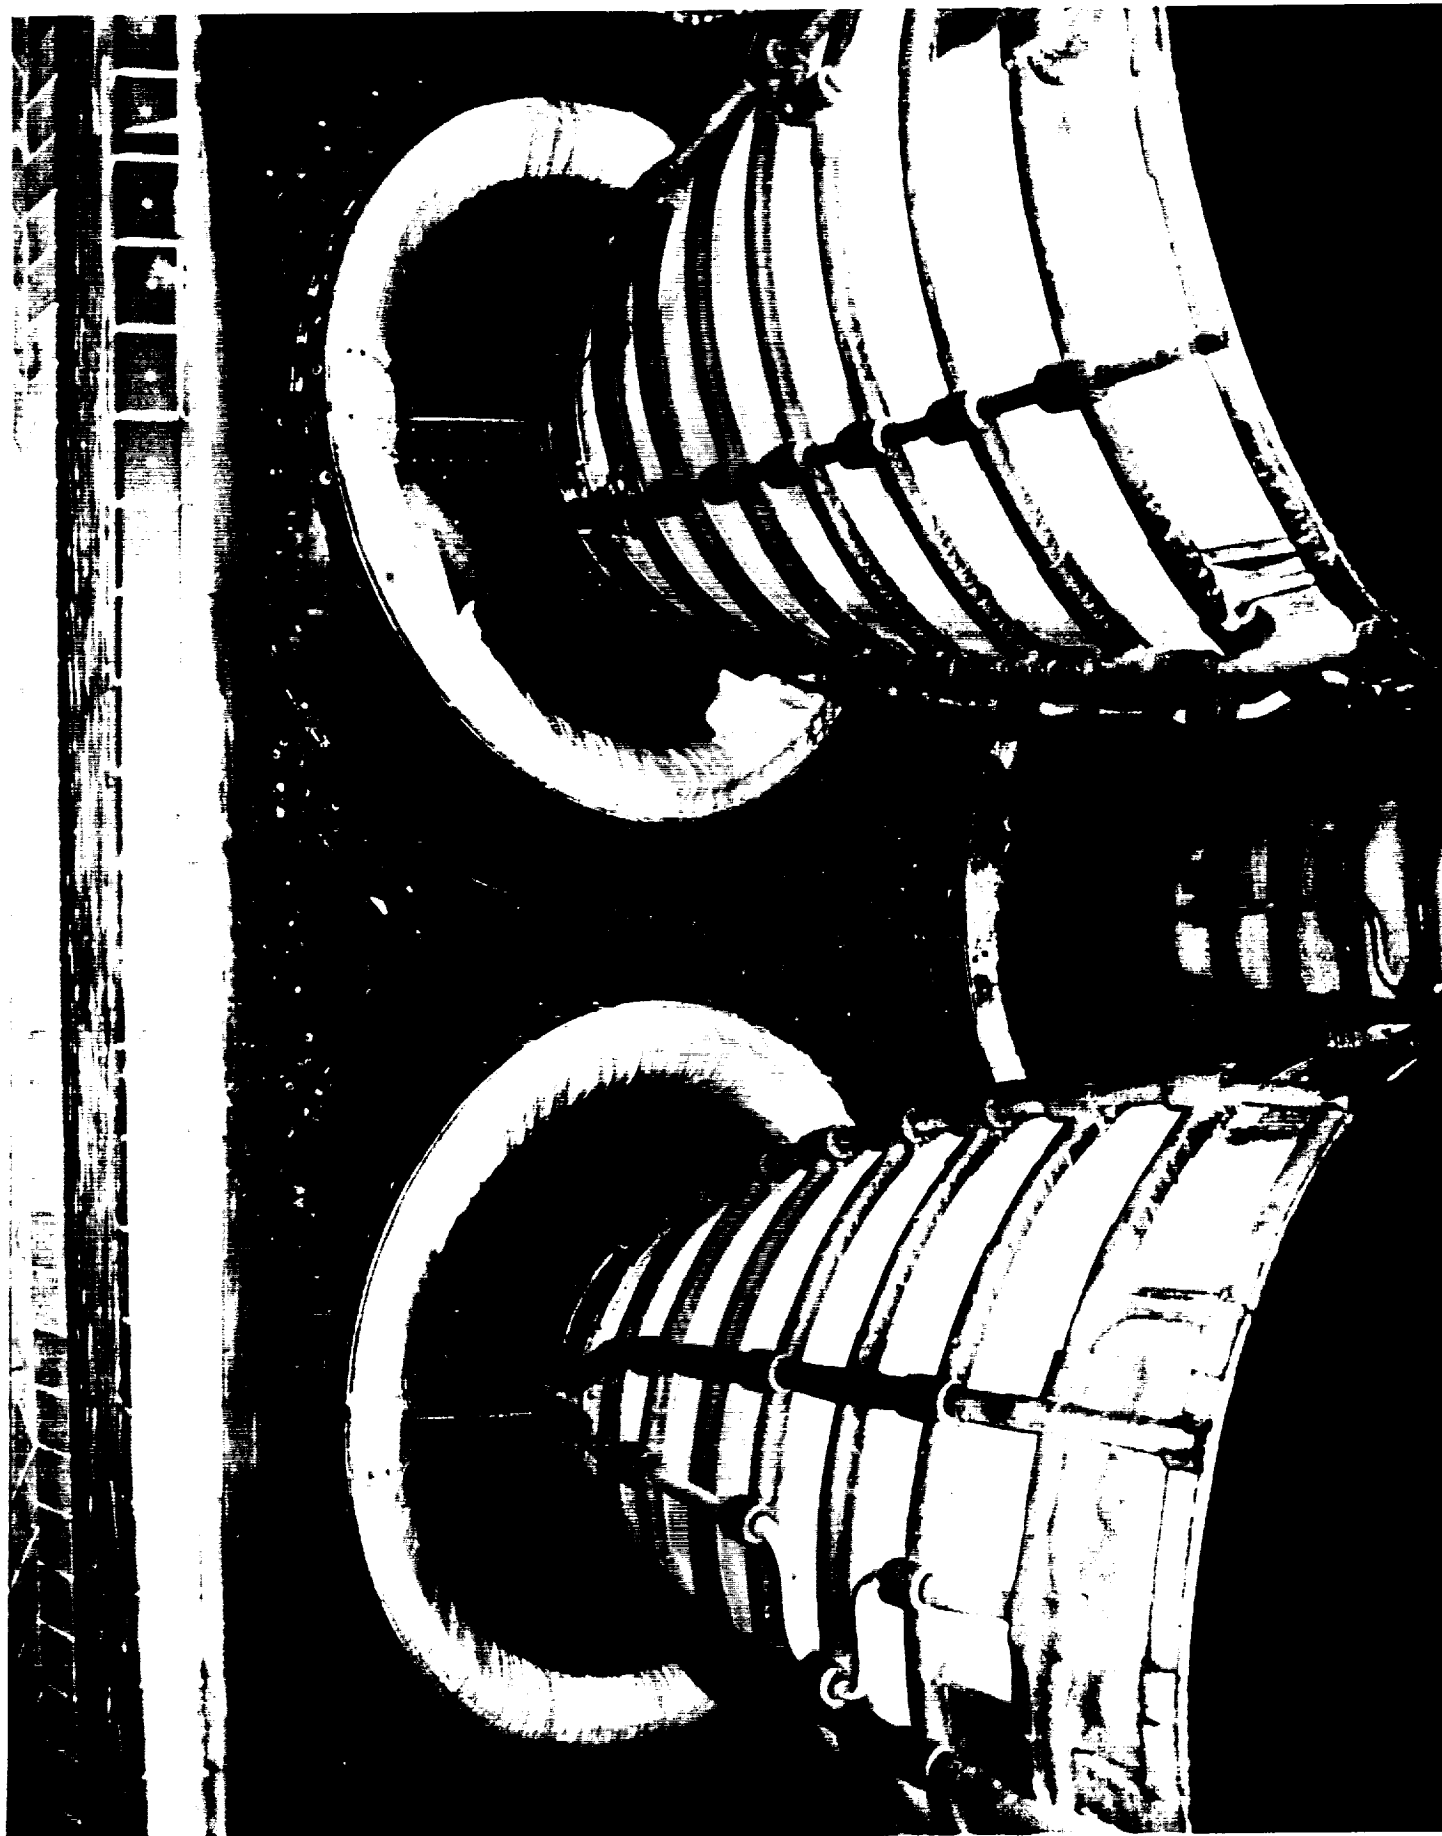
Overall view of SSME's. Damage to the base heat shield tiles was average with approximately 150 sites. All three SSME closeout beta blankets were frayed in localized areas.

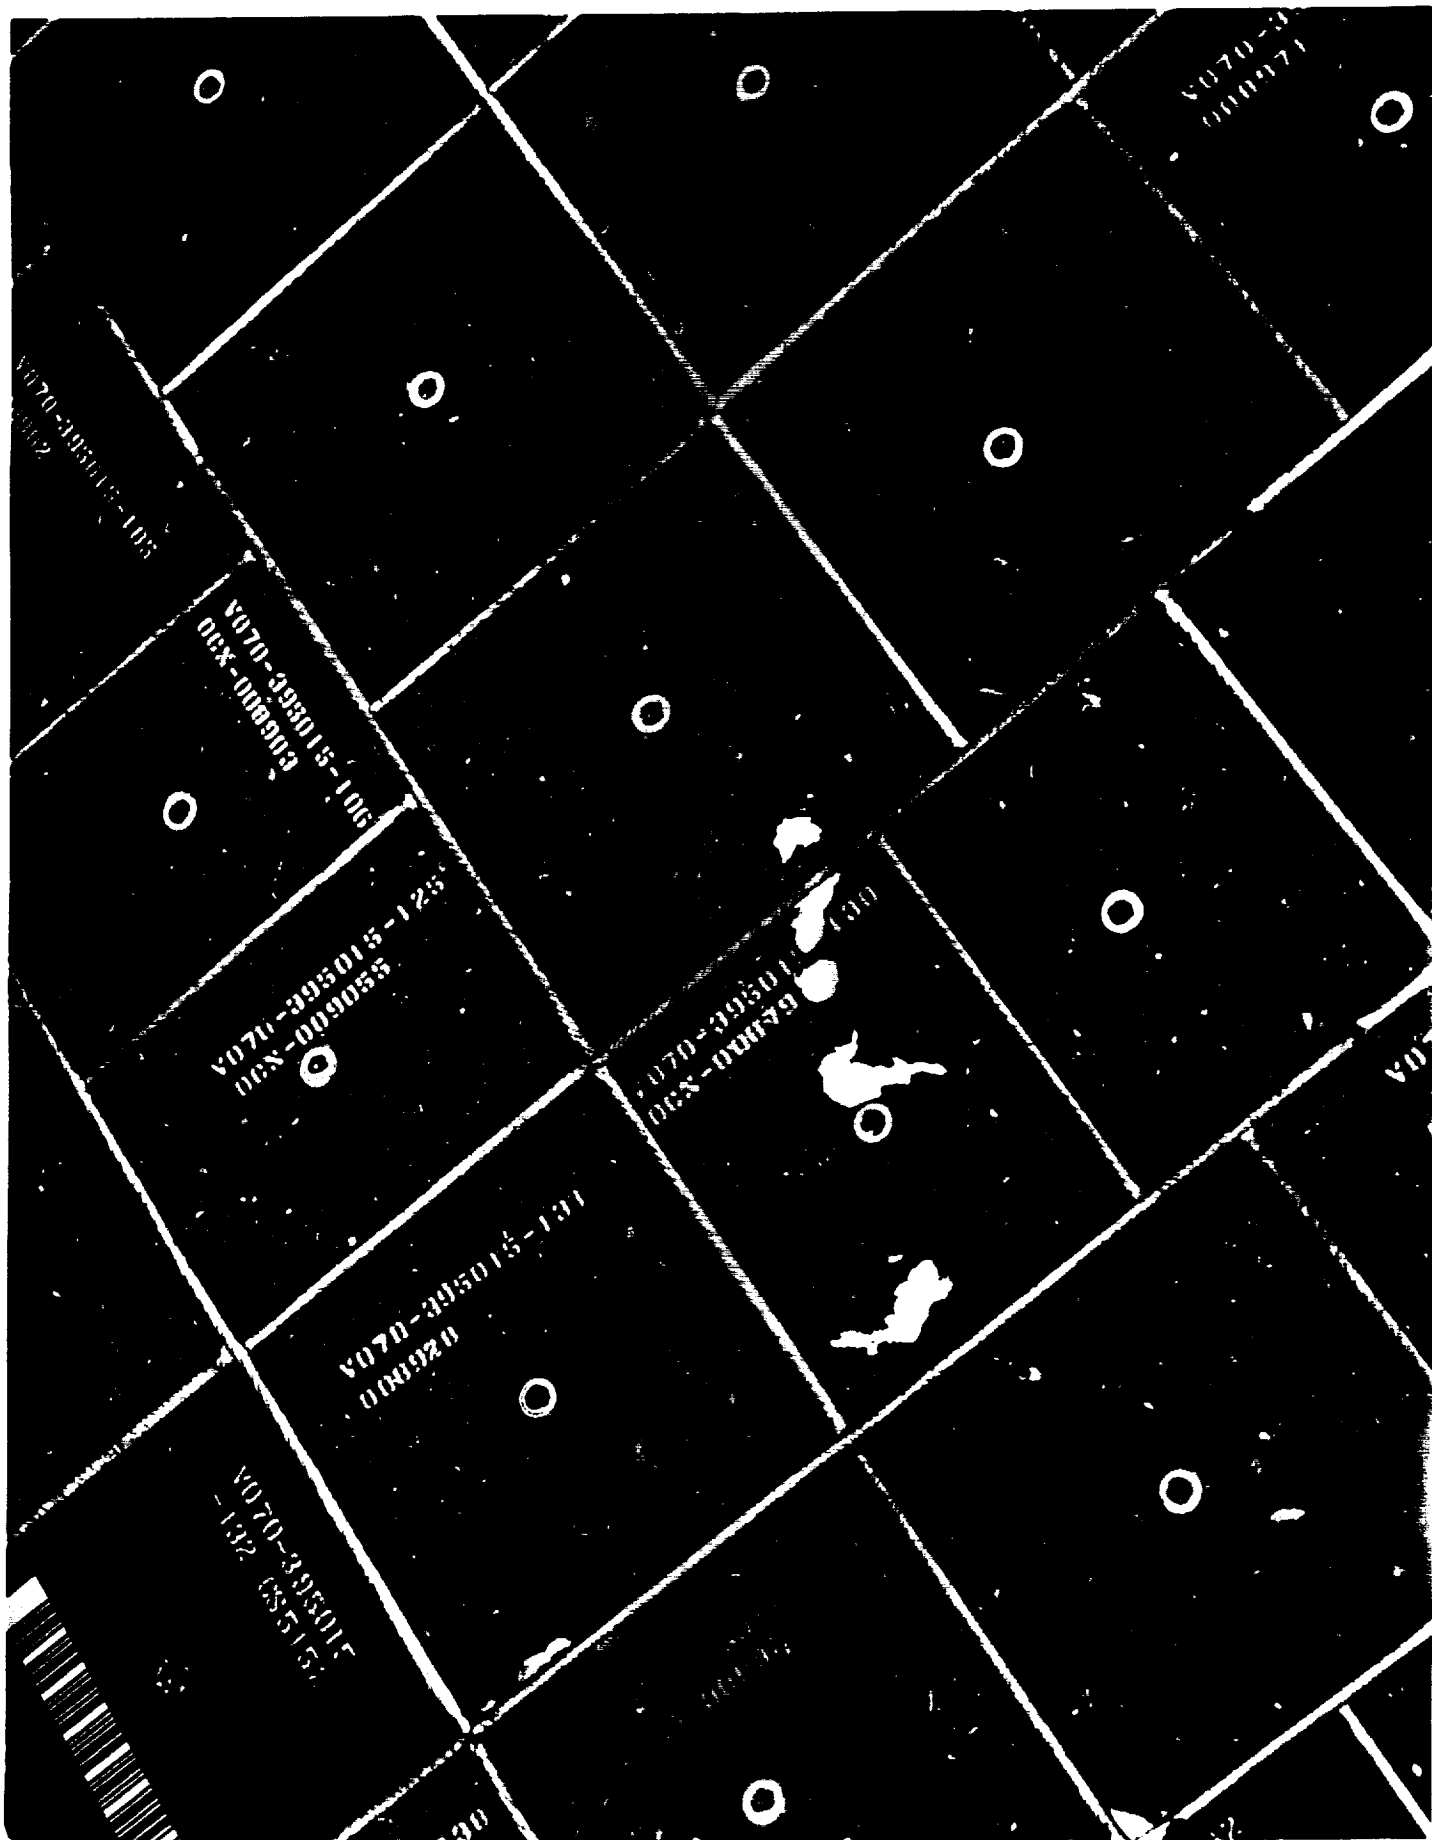
A total of 18 hits occurred on the body flap lower surface.  
Some of the damage sites reached depths of 1/4 to 1 inch.

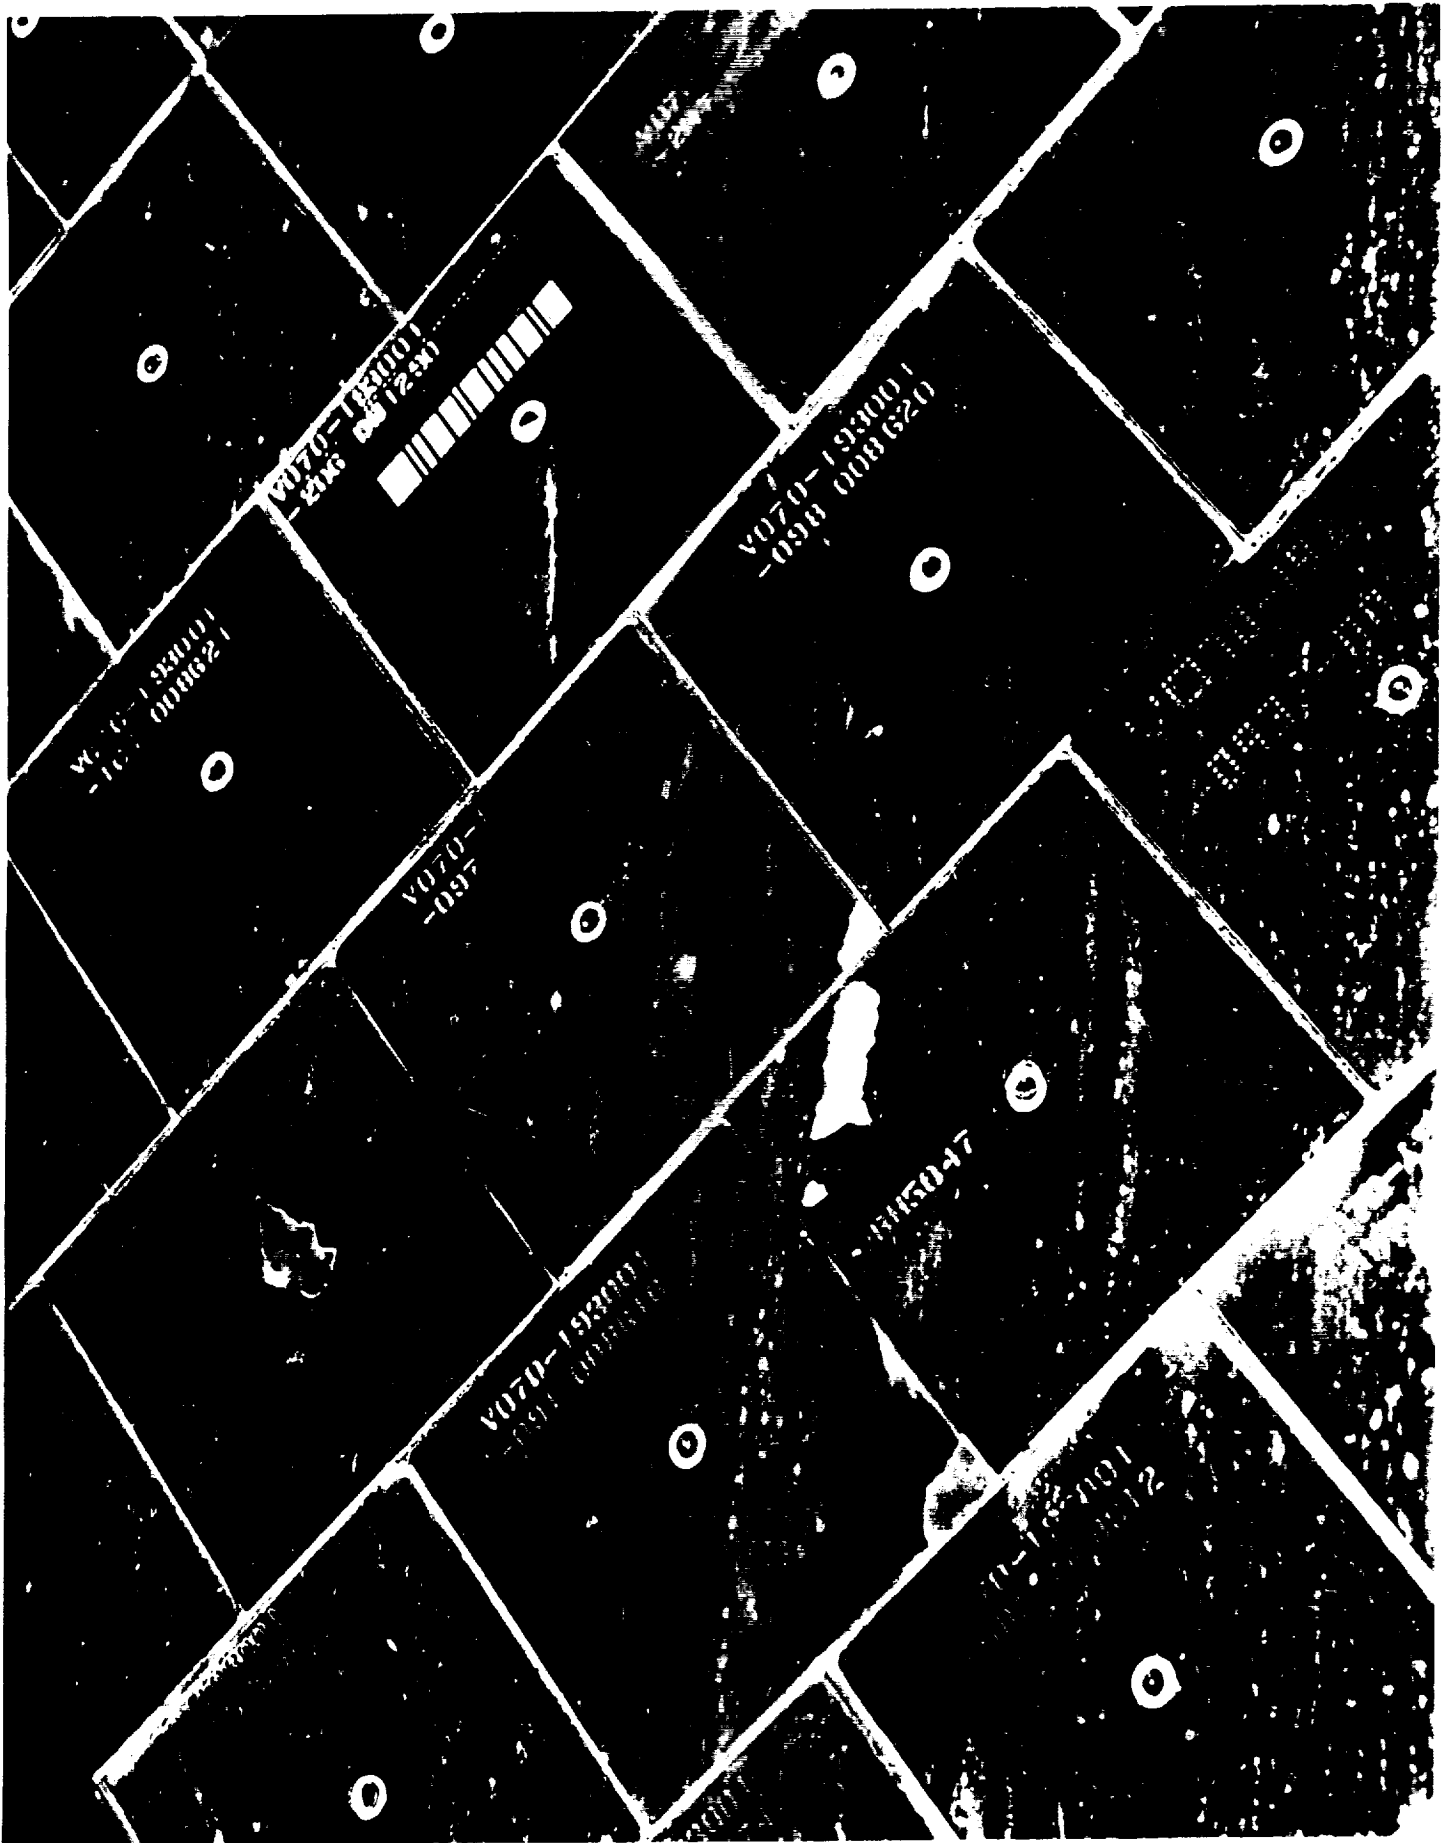
Typical debris impact damage to lower surface tiles
